Inspection Report Minerals Regulatory Program October 6, 2009

Mine Name: Daddy Dearest	Permit Number: S/015/0046
Operator Name: T. J. Clark	Inspection Date: 08/20/2009
Inspector(s): Brett Gregory for Wayne Western	Time: 4:00 pm
Other Participants: None	Mine Status: Inactive

Purpose of Inspection: This was a routine inspection of the site.

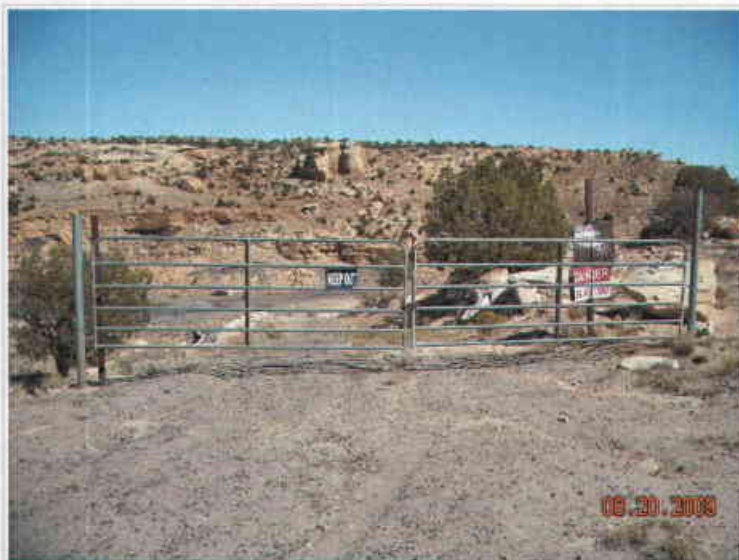
Secured gate. (No issues found)

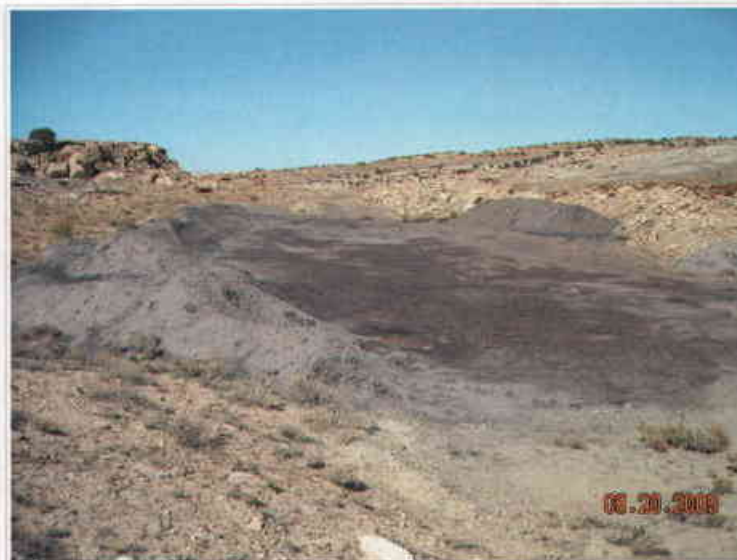
Ore stockpile location. (No issues found)

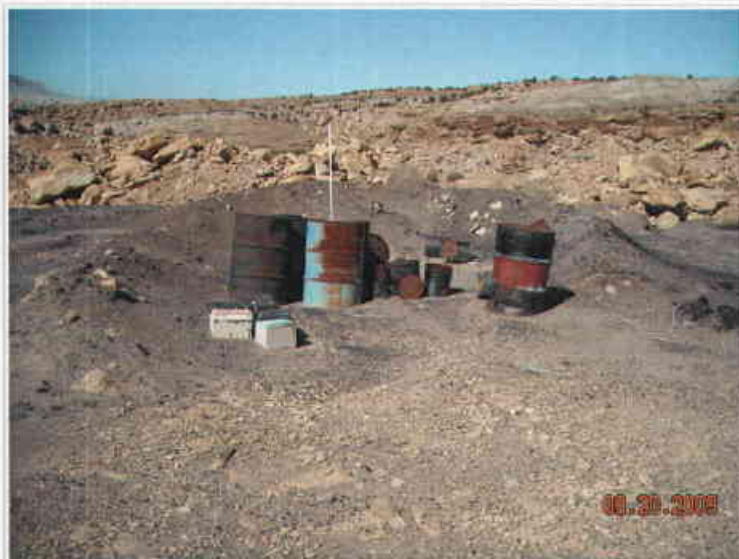
- 1) The bond escalation date is 10/16/2010.
- 3) There are deep ruts in the road shown in the photographs below that need to be repaired (see regulation R647-3-107.3).
- 4) Several containers found were not labeled and have unknown fluid in them. Materials left in this condition require either (1) removal of the substance from the site, or (2) construction of a containment facility to properly label and store the material. Whichever option is chosen will have a fixed cost associated with it. In this case, if the substances are going to be left on site, then the reclamation bond will likely need to be increased. Additionally, if the substances are to be removed and are not done so in a timely manner, then enforcement action may be taken and an associated fine applied. (See regulation R647-3-107.4)

The old batteries found in the photographs below will also need to be disposed of or appropriately stored.

These batteries and canisters must be labeled and contained properly.

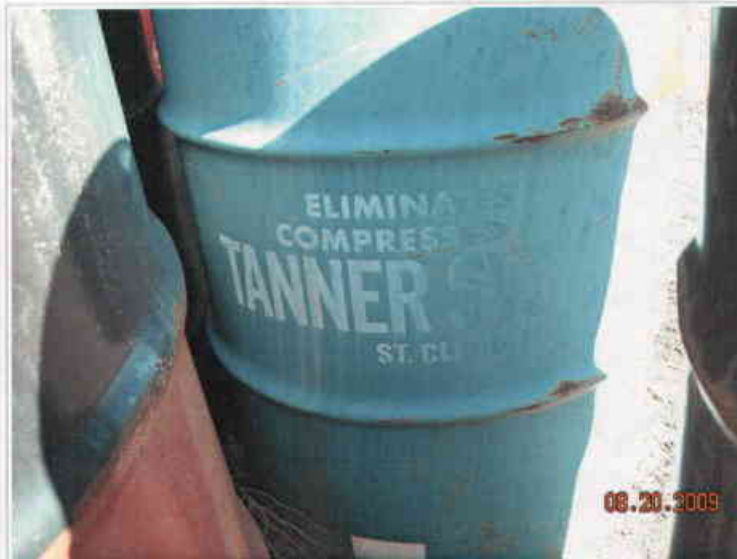
Possibly the only container labeled.

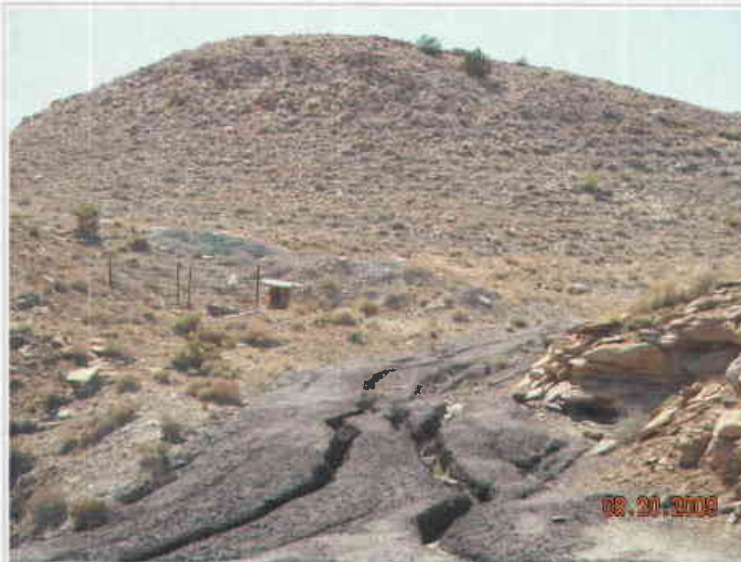
Erosion problem needing some sort of remediation.

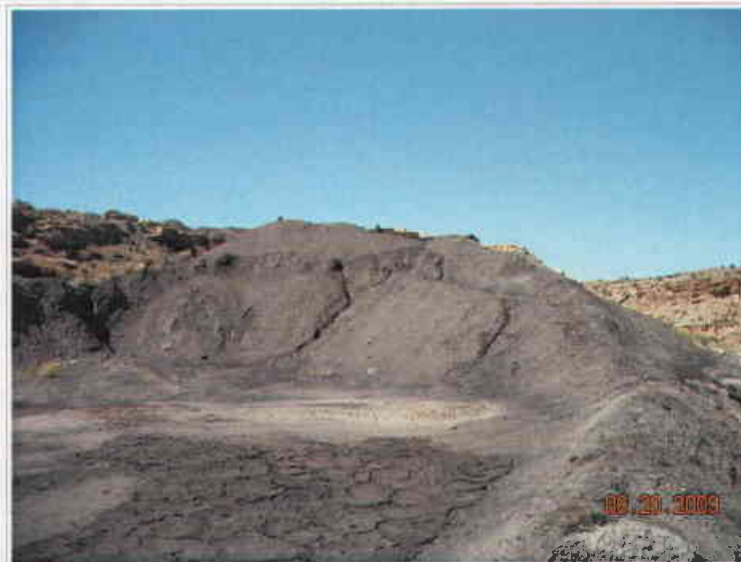
Lower stockpile with established reels and mud cracks.

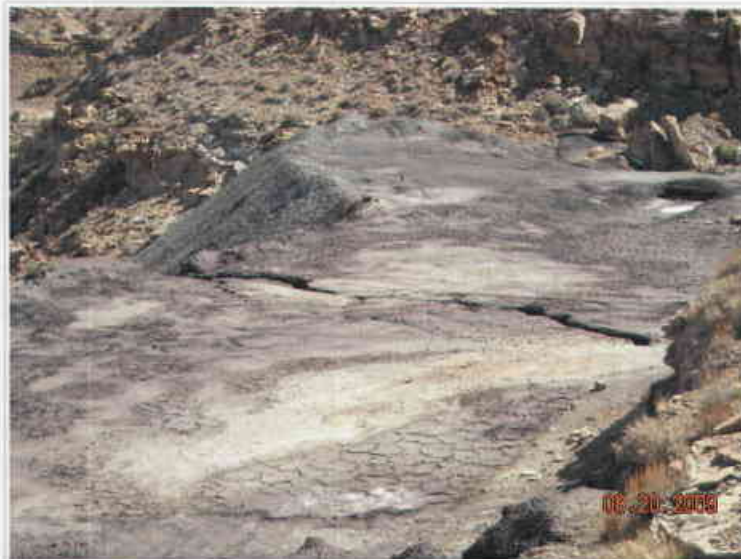
Lower pad where runoff has accumulated and breached the perimeter.

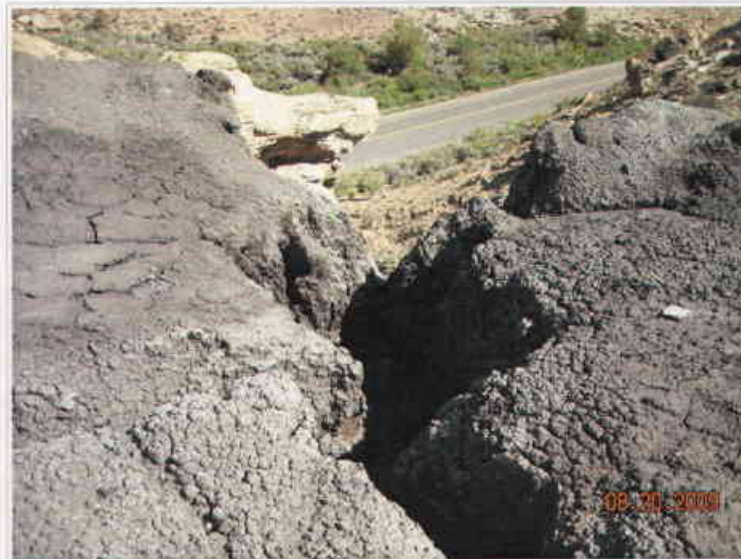
A sediment trap or berm repair is needed here.

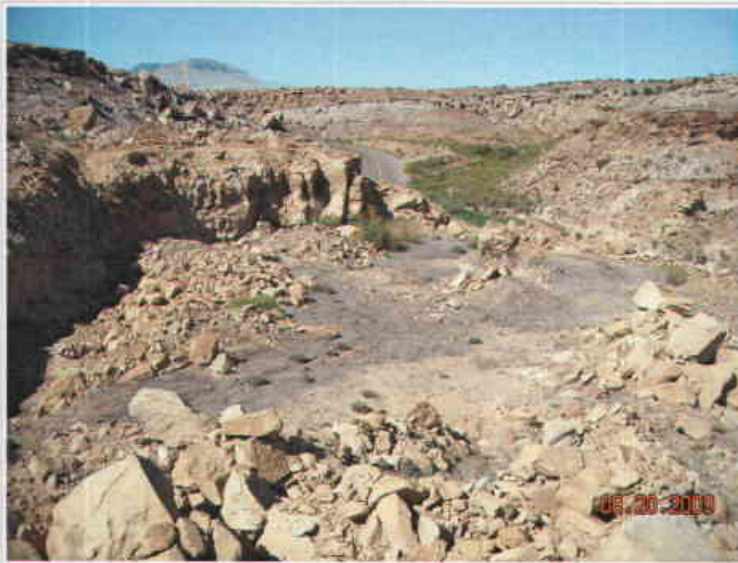
Loose rock. (View of disturbance furthest to the north.)

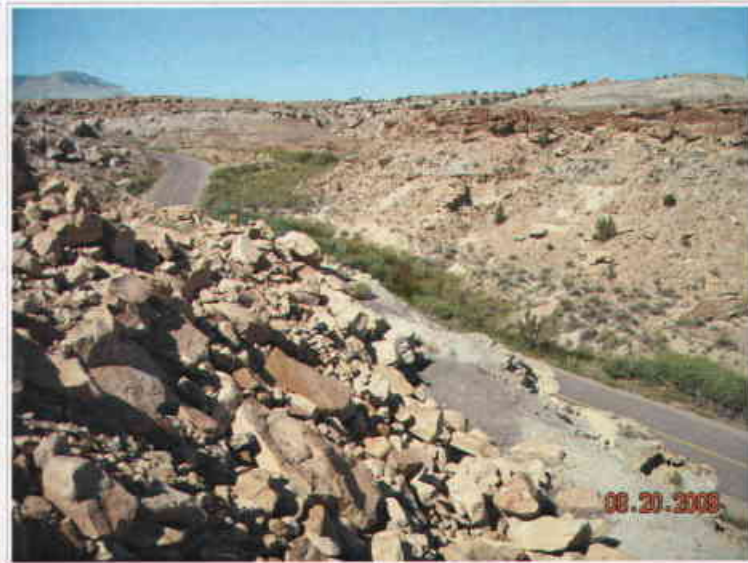
- 12) Several large boulders are on a 45-degree slope and present a possible safety hazard. The rocks have the potential to roll onto the public road below. The Division and the Bureau of Land Management require the site be safe. (See regulation R647-3-107.1).

Potentially unsafe rock that may roll down to the road below.

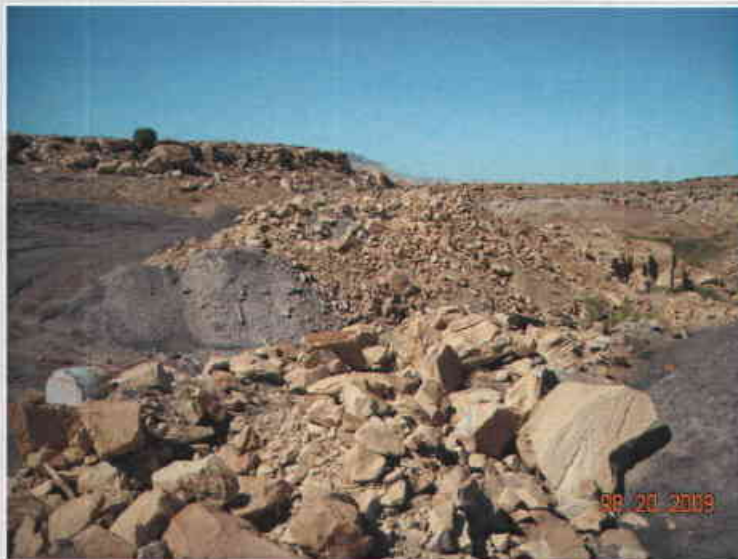
Piled rock and overburden.

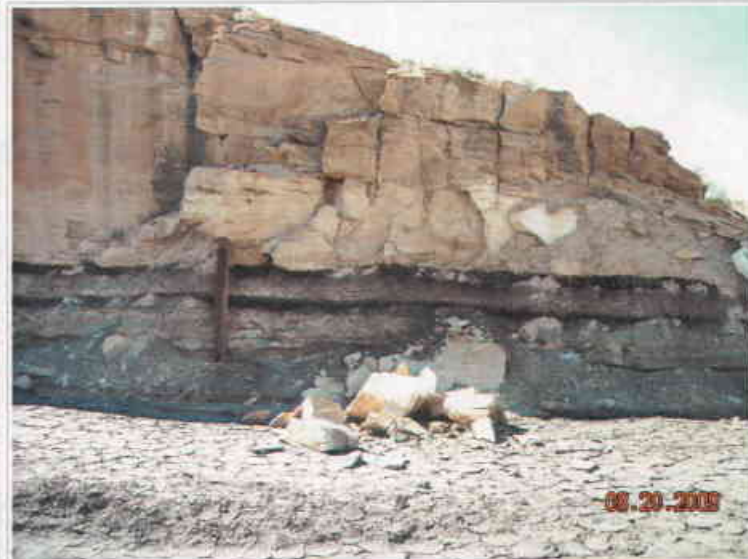
Rock that has dislodged from a highwall.

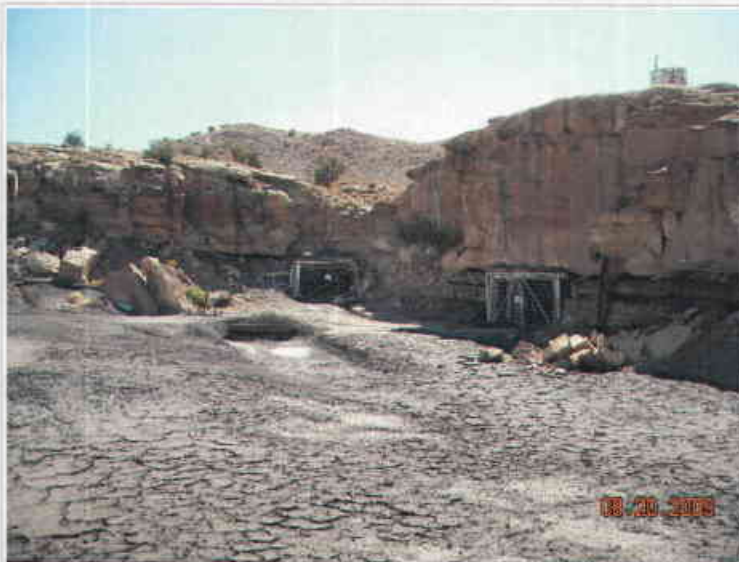
Portals. (No issues found)

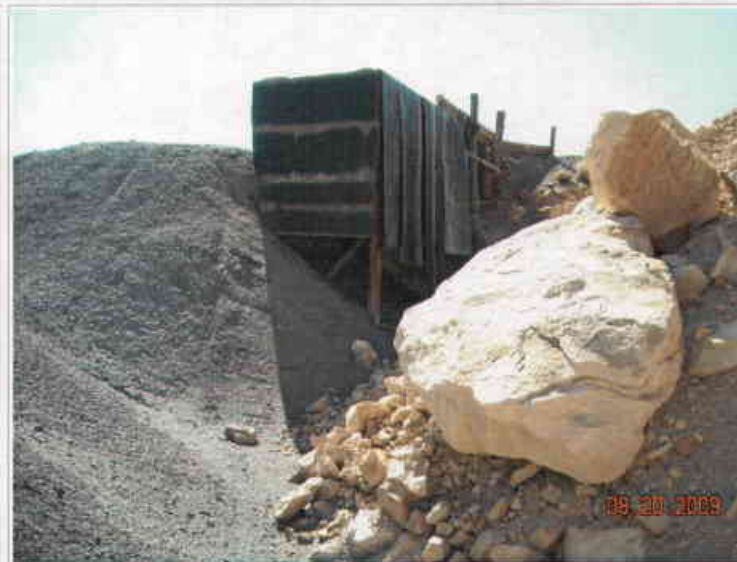
Adit. (Potentially unstable rocks on the right?)

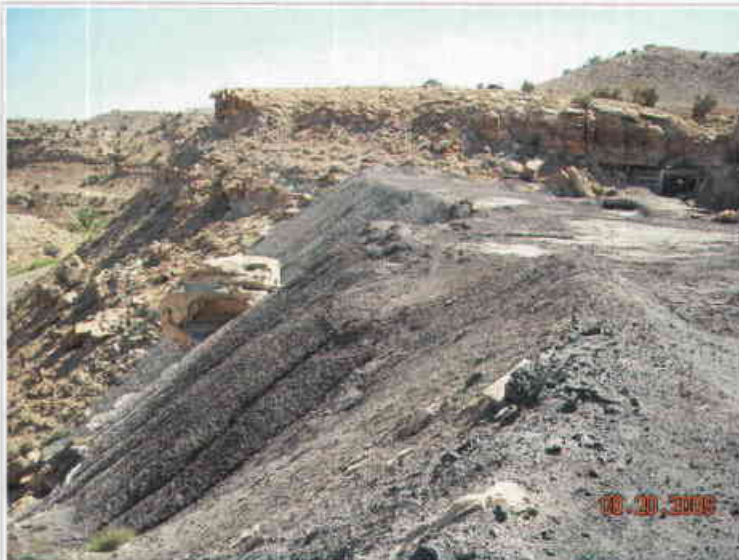
Overburden and visible reels. (Sediment is not allowed to leave the site.)

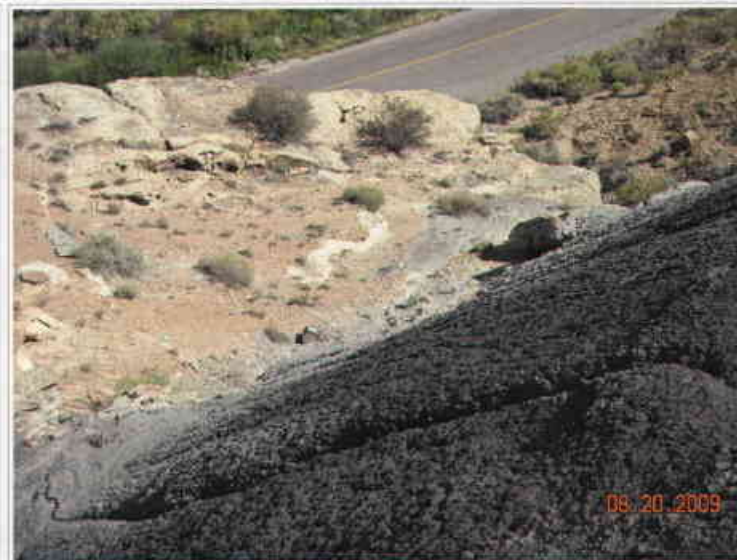
Ephemeral runoff that has carried sediment from the disturbance.
